### Inspection Report Minerals Regulatory Program Report Date: September 15, 2004

**Mine Name:** Miller Rock/Bret Clark Mine

**Permit number:** S/015/043

**Inspection Date:** July 2, 2004

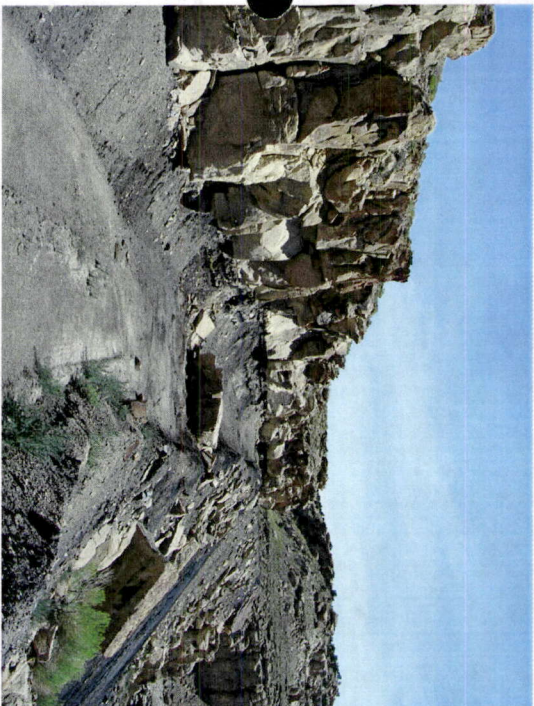
Since the last inspection, some rock has fallen on to the pad in front of the portals (Photo 1). There are a few places where additional rock looks like it is about ready to fall, but at Bret Clark's mine, I do not believe there is much danger to the public. There is some danger to the operator.

**Photo 1. A large piece of sandstone that has fallen on to the pad in front of the portals.**

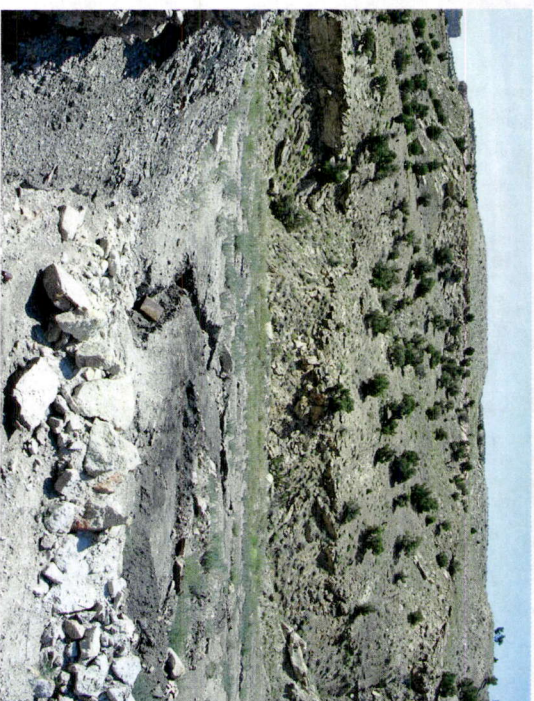
There have been some storms in the area, and some of the sediment control structures need maintenance work (Photos 2 and 3). Photo 3 is a berm at the top of the hill leading down to the portal level. It keeps water that accumulates on a level above the portals from running down the hill then over the edge in front of the portals. This area has been a maintenance problem, and the operator may want to consider other drainage control options for this area.

**Photo 3. Part of a breached berm at the top of the hill above the portals. Sediment from this area ends up on the portal pad and down the outslope of this pad.**

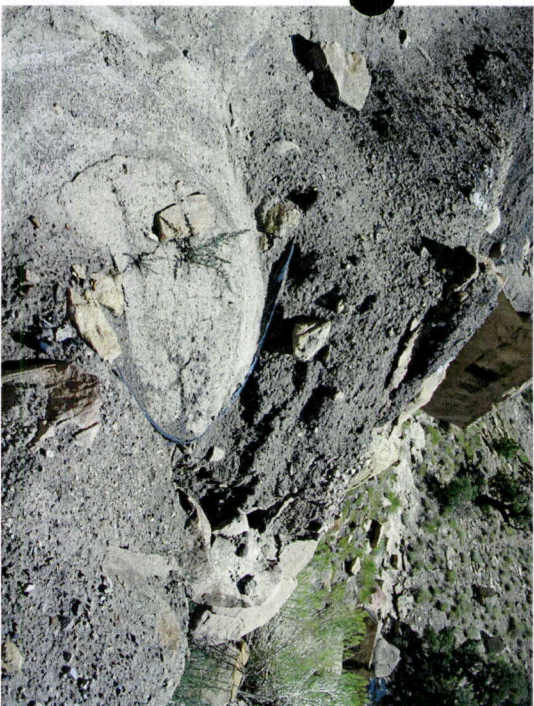
**Photo 2. A silt fence in front of the portals, that needs maintenance. Much of this sediment comes from the area shown in Photo 3.**
